CORROSION ON COUPLINGS AND HARDWARE

Antonio Soler (Product & Project Manager)

DISTRIBUTOR SUMMIT

CORROSION IN FLEXIBLE COUPLINGS

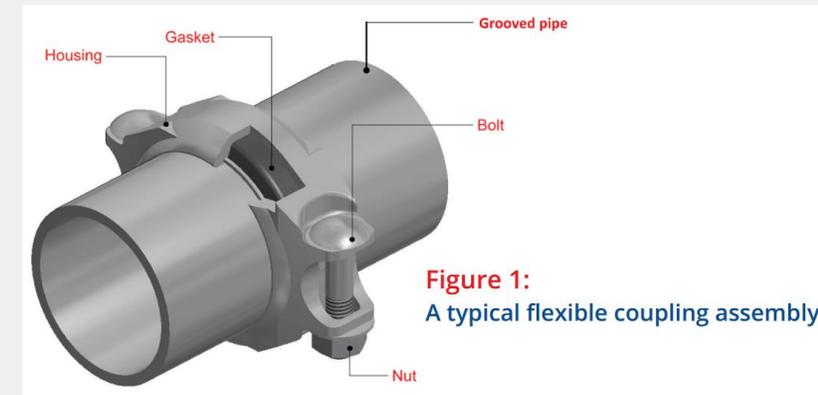
Figure 1:
A typical flexible coupling assembly

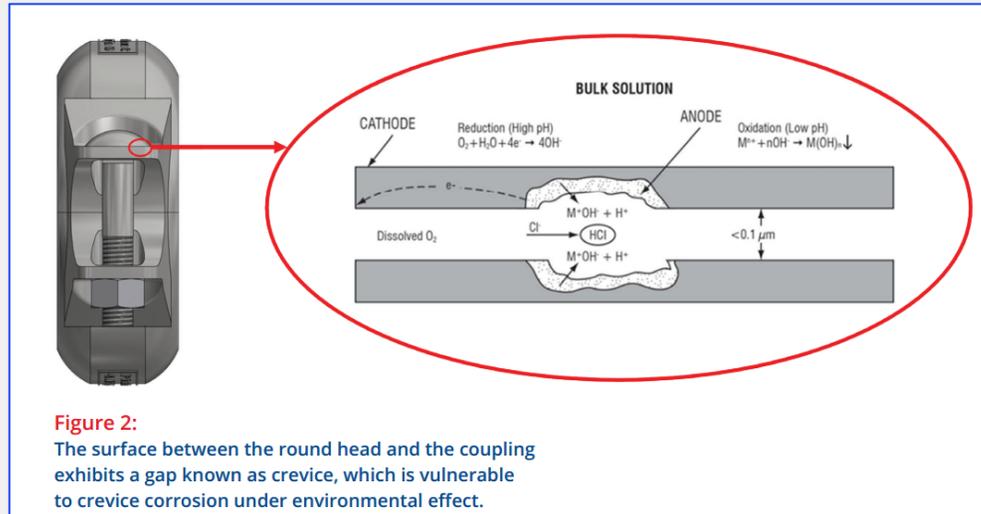
Figure 2:
The surface between the round head and the coupling exhibits a gap known as crevice, which is vulnerable to crevice corrosion under environmental effect.

SCC happens because of the combined effect of the microstructure cracks in austenitic stainless steel and the torque/pressure combination of the grooved coupling. Under torque and pressure, the microstructure crevices are forced open by the stresses and propagate through the material. Most fasteners are cold-worked, which means they inherently have internal residual stress within the structure. Furthermore, they are subjected to the stress caused by the torquing required to close the assembly. SCC can happen at stresses that are below the yield stress of the metal. Vibration, and thus fatigue, may lead to acceleration of the phenomenon.

SCC is difficult to eliminate and premature failure of bolts is difficult to predict. Piedmont recommends that its clients follow the torque guidelines provided in the operation manual and regularly inspect the coupling assembly for premature signs of corrosion.

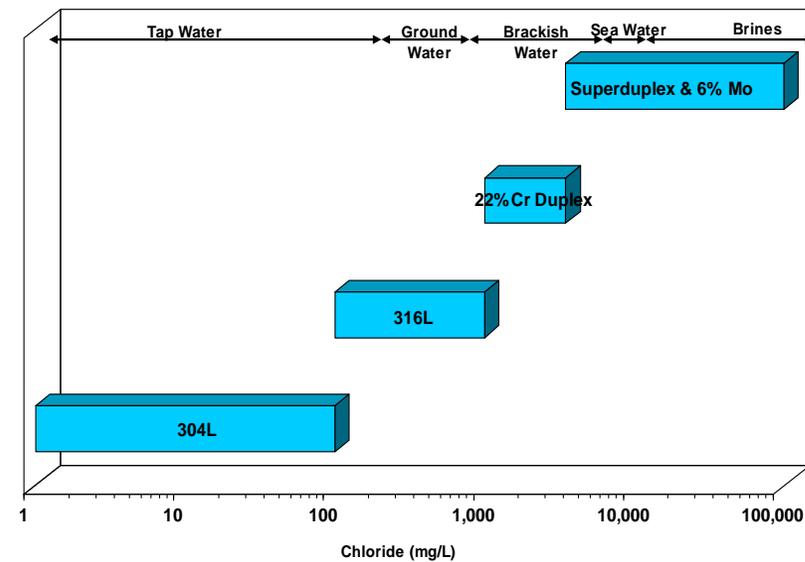
PREN:

~25

~35

>40

Safe chloride range to avoid crevice corrosion at 20°C

For stainless steels in chloride solutions there is a linear relationship between pitting and crevice corrosion resistance and alloy chemistry as defined by the Pitting Resistance Equivalent number (PREN) and the Crevice Factor (CF).

Stainless Steel	Maximum Recommended Chloride Level
304/304L	200 ppm
316/316L	1000 ppm
317LMN, 904L, & 2205	3000 - 5000 ppm
6% Mo grades & 2507	Resist seawater (20,000 ppm)

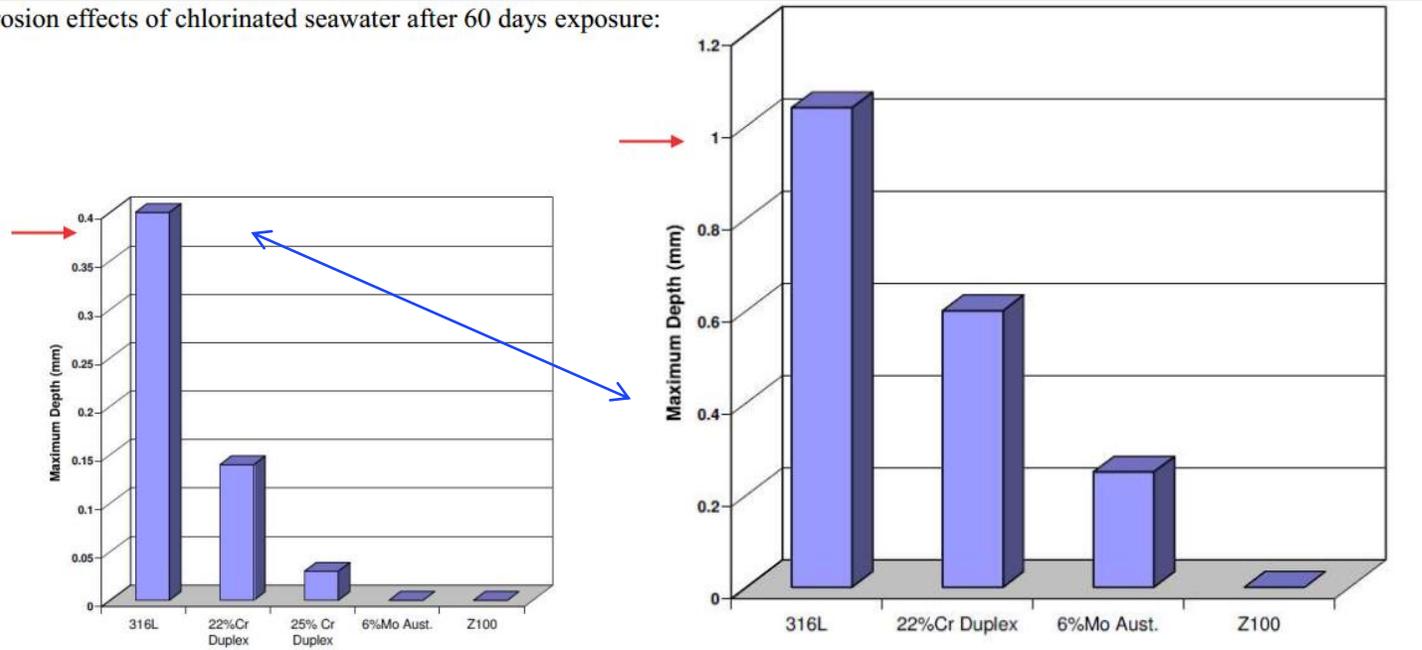
Corrosion effects of chlorinated seawater after 60 days exposure:

Figure 4 Depth of crevice corrosion in seawater at 16°C with 1mg/L chlorine⁶. Figure 5 Depth of crevice corrosion in seawater at 40°C with 1mg/L chlorine⁶.

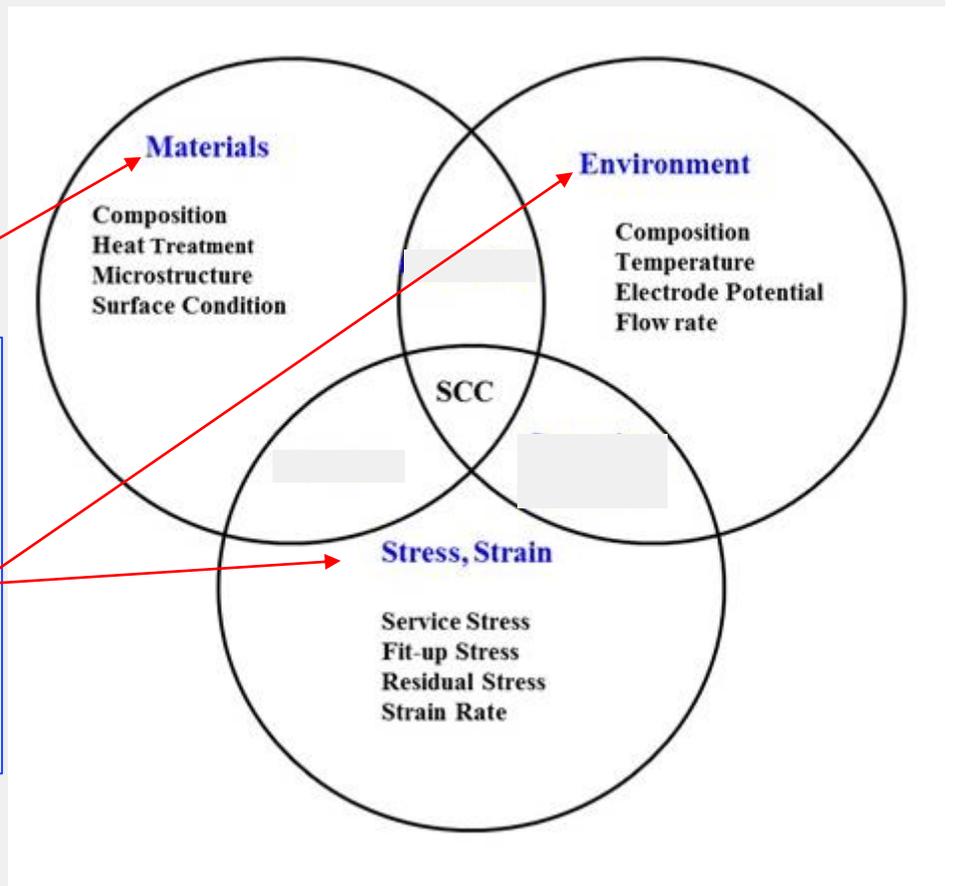
Chloride Stress corrosion cracking (CSCC):
Main factors

Human factor:

- Bolt Material selection in RFQ (\$\$):
2205 duplex/2507 super duplex Vs SS316
- Bolt assembly torque
- Couplings maintenance & racks leakings at SWRO site

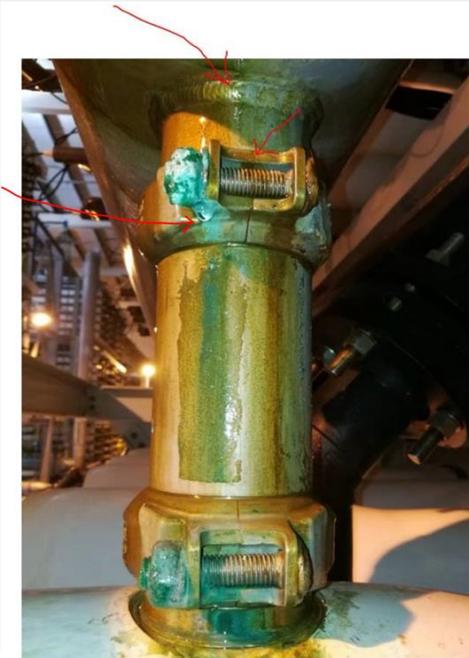
It is important to know what to look for when inspecting bolts for signs of premature corrosion. A good rule is to assume that if there is some visible rust on the head of the bolt, there is likely some more severe corrosion in the enclosed spaces in the bolt assembly. The following pictures shows bolts that should be replaced, based on that rule.

Figure 3:
In some cases the head of the bolt may look like the one in the following pictures

During plant or train shut down for maintenance, a few couplings showing signs of corrosion, as well as a few randomly selected couplings, should be dismantled and inspected. The bolts should be replaced immediately if there is a doubt about their integrity. Such inspection should be conducted at least every six months. Piedmont also recommends the replacement of all hardware every five years; or more frequently if in doubt.

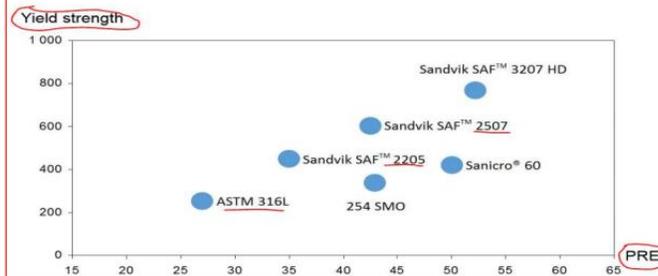
For marine applications PRE > 40 is recommended and the following diagram compares the PRE and yield strength for a number of currently used grades.

Stainless steel material in contact with seawater or seawater concentrate shall have an actual Pitting resistance equivalent number (PREN) of at least 40 and a Crevice factor (CF) of at least 35, to be calculated as follows:

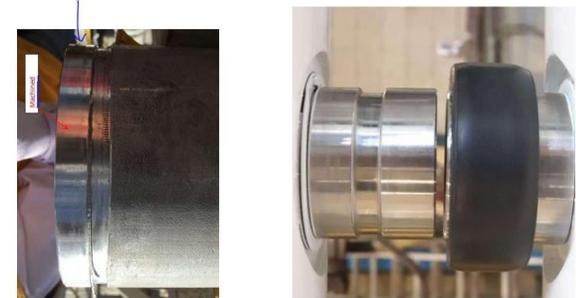
For instance, the surface machining of the gasket seating area has been reported to increase resistance against crevice corrosion attacks.

By machining a small amount of metal from the land for the gasket rubber seal is a simple, low cost operation and enhances the level of crevice corrosion resistance.

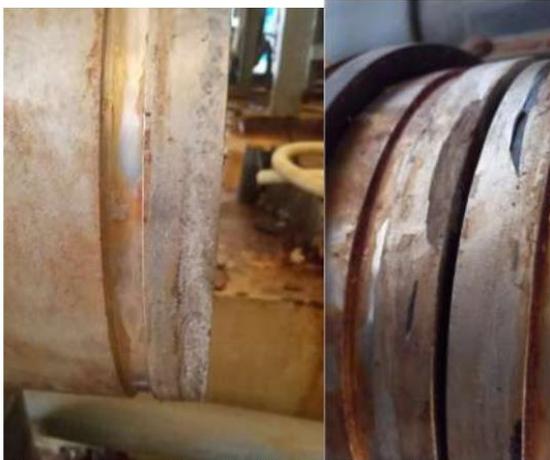
Once assembled, the coupling – pipe groove joint creates a tight crevice, and some customers reported experiences with lower alloy stainless steels piping (PREN < 40) which suffered severe crevice corrosion in SWRO plants, like the below photo examples:

Photo: High pressure S32205 duplex piping (PREN ~35) with crevice corrosion observed after coupling disassembled (Egypt) (not Piedmont coupling)

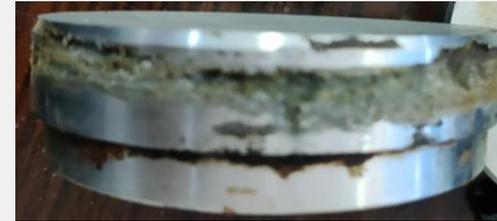
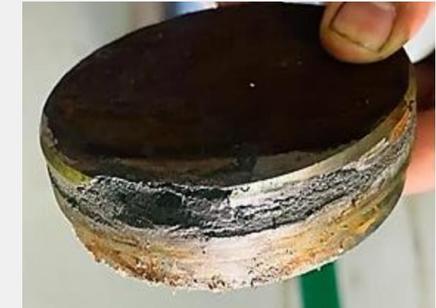
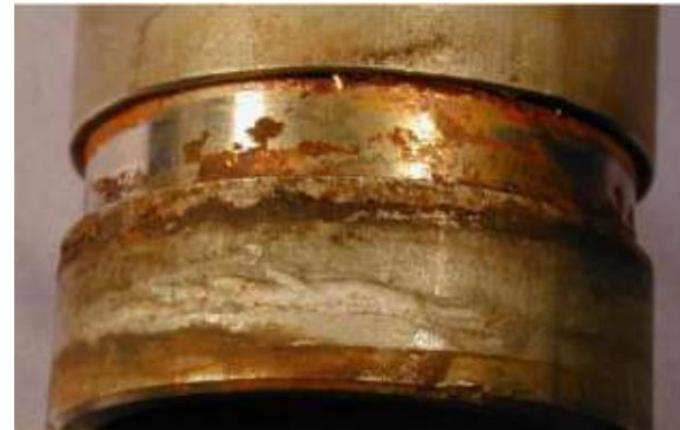
Corroded casted CE8MN-SD endcap (at high pressure seawater & brine):
To use instead superduplex CE3MN (casted) or S32750 (2507) forged

Photo: Crevice corrosion of 316L at high pressure coupling pipe joint

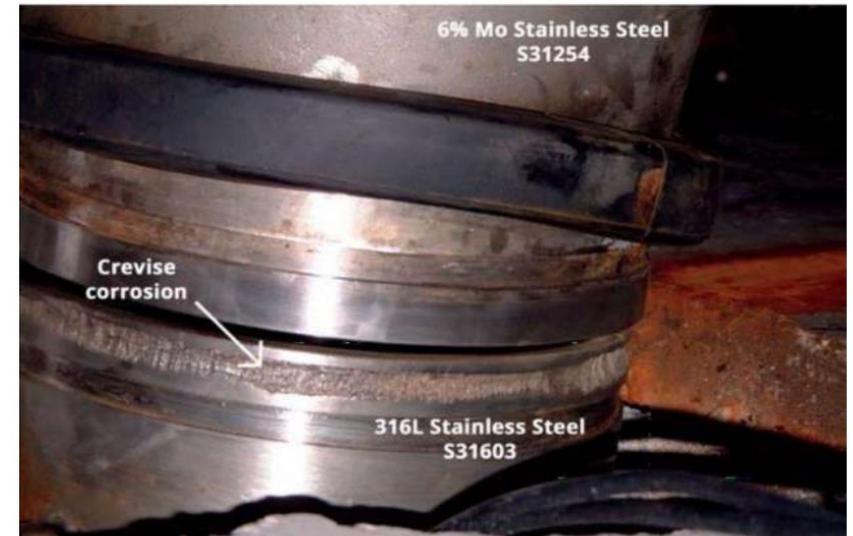
Photo: High-pressure coupling- pipe assembly from a 40,000 m³/day seawater RO plant in the Mediterranean sea. The 6% molybdenum coupling pipe part was in service for 7 years compared to only 6 months for the opposite 316L coupling pipe part. [1]

- A) To use pipe materials with higher crevice and pitting resistance No (PREN > 40), such as:
- Alloy 2507 (Superduplex S32750)
 - Zeron 100 (RA Alloys)
 - AL6XN (Allegheny-Ludlum)
 - 254SMO (6Mo) (Outokumpu)

The type 316, type 904L stainless, and alloy 2205 (S32205) duplex pipe material are not allowable piping materials for this high pressure rating in seawater.
